Fishing Run - HON GT-01-S1 Spear LIH

Timo Hein, Product Line Manager

August 18th, 2015

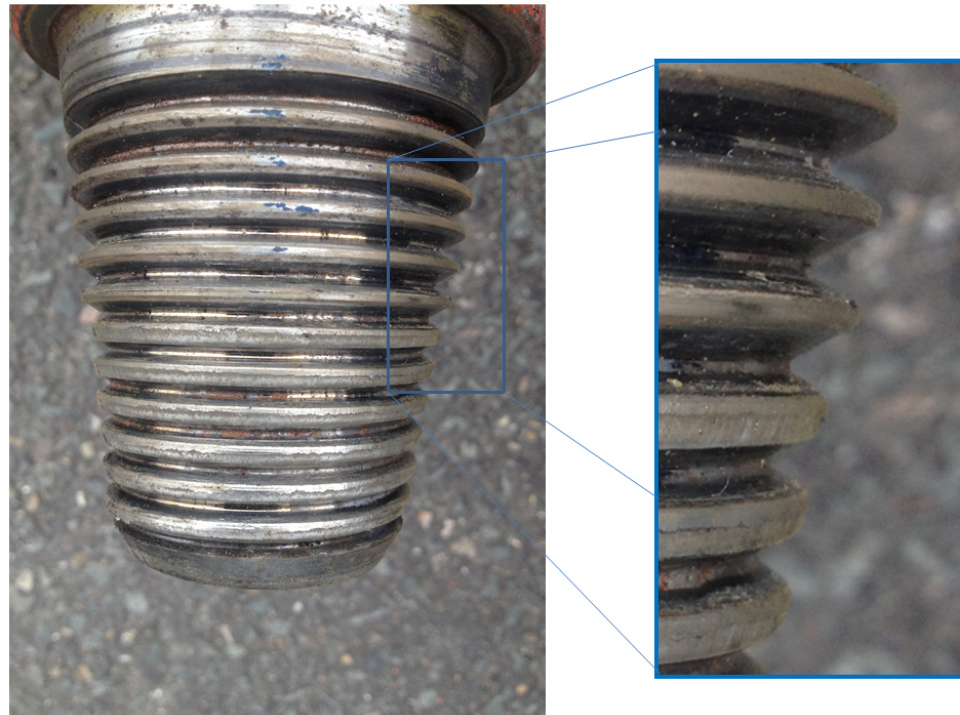
The Itco Spear was attached to a spacer (WG3053, see BHA details).

The lower pin connection showed signs of wear on the lower two thirds of the threads.

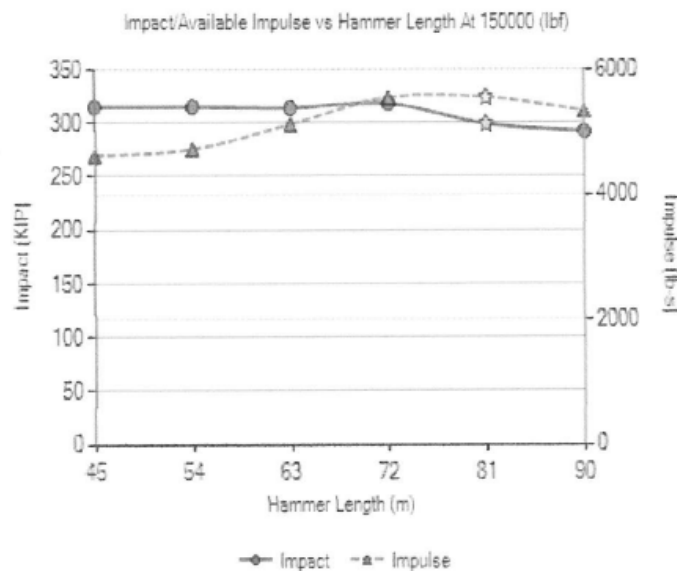
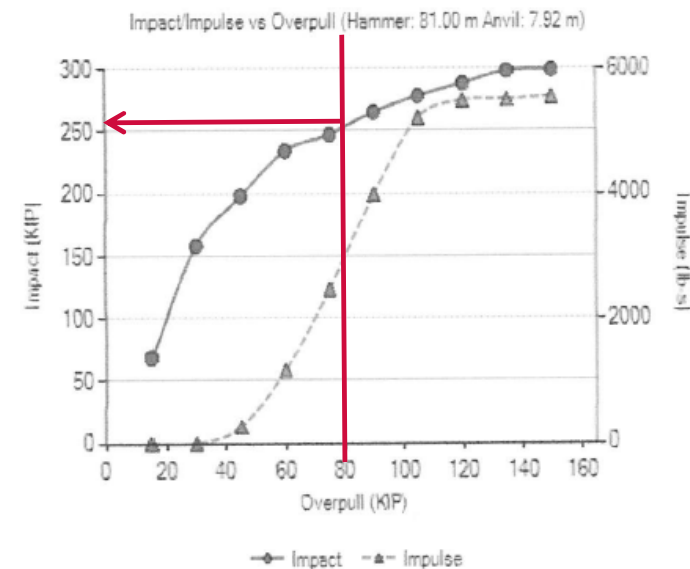
Knut and Thomas (the second field hand) ran a jar placement simulation before the BHA was run in hole. The calculations resulted in the following numbers:

With a calculated impact of 260Klbs they stayed quite safely away from the tensile limit of the 2-3/8" Regular Box (375Klbs) or even 80% of the tensile yield (300Klbs).
